QFlash User Guide

Rev. QFlash_User_Guide_V2.2

1 Introduction

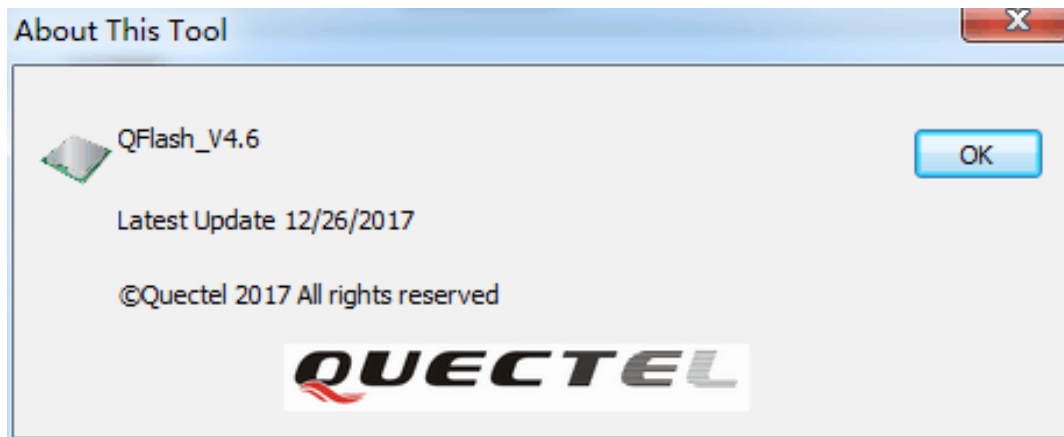
The QFlash tool developed by Quectel is shown as below.

Figure 1: About the Tool

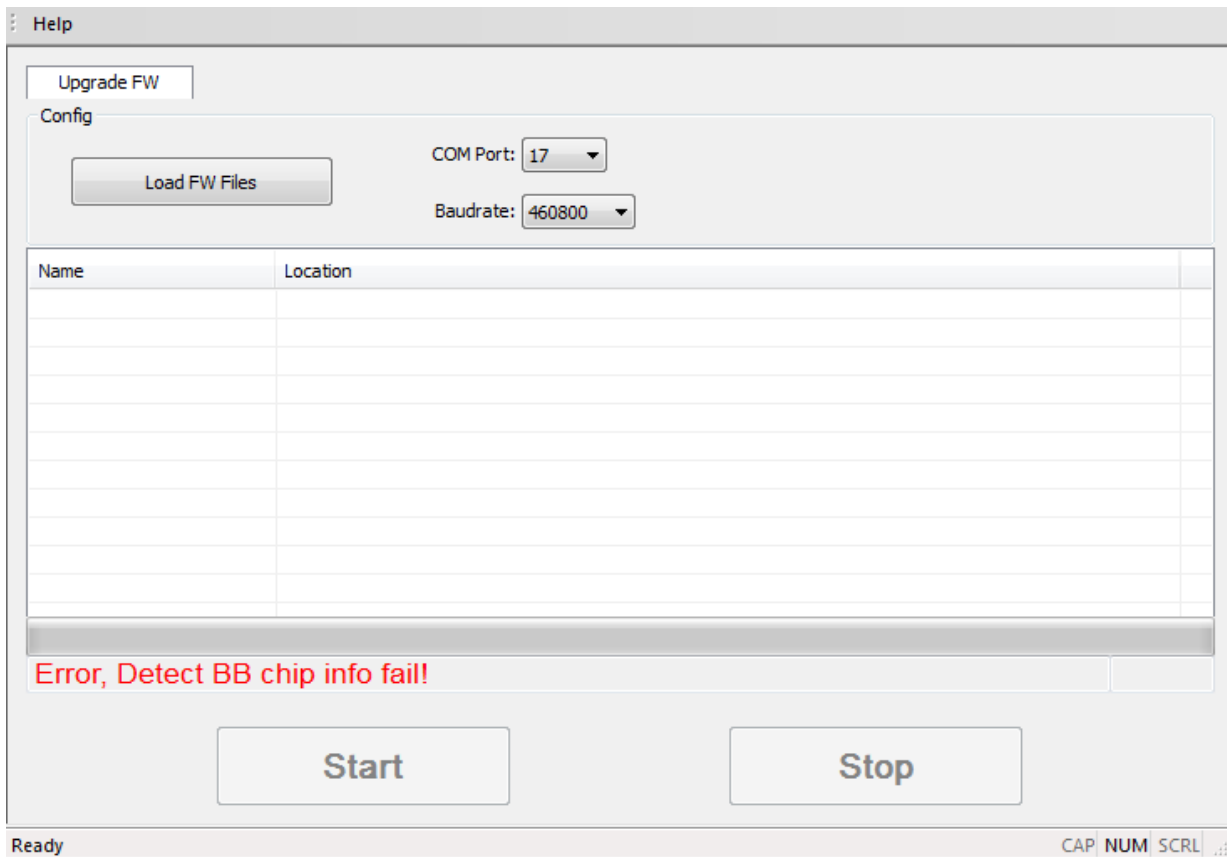
When QFlash tool is opened, the main interface will be shown as below.

Figure 2: Main Interface

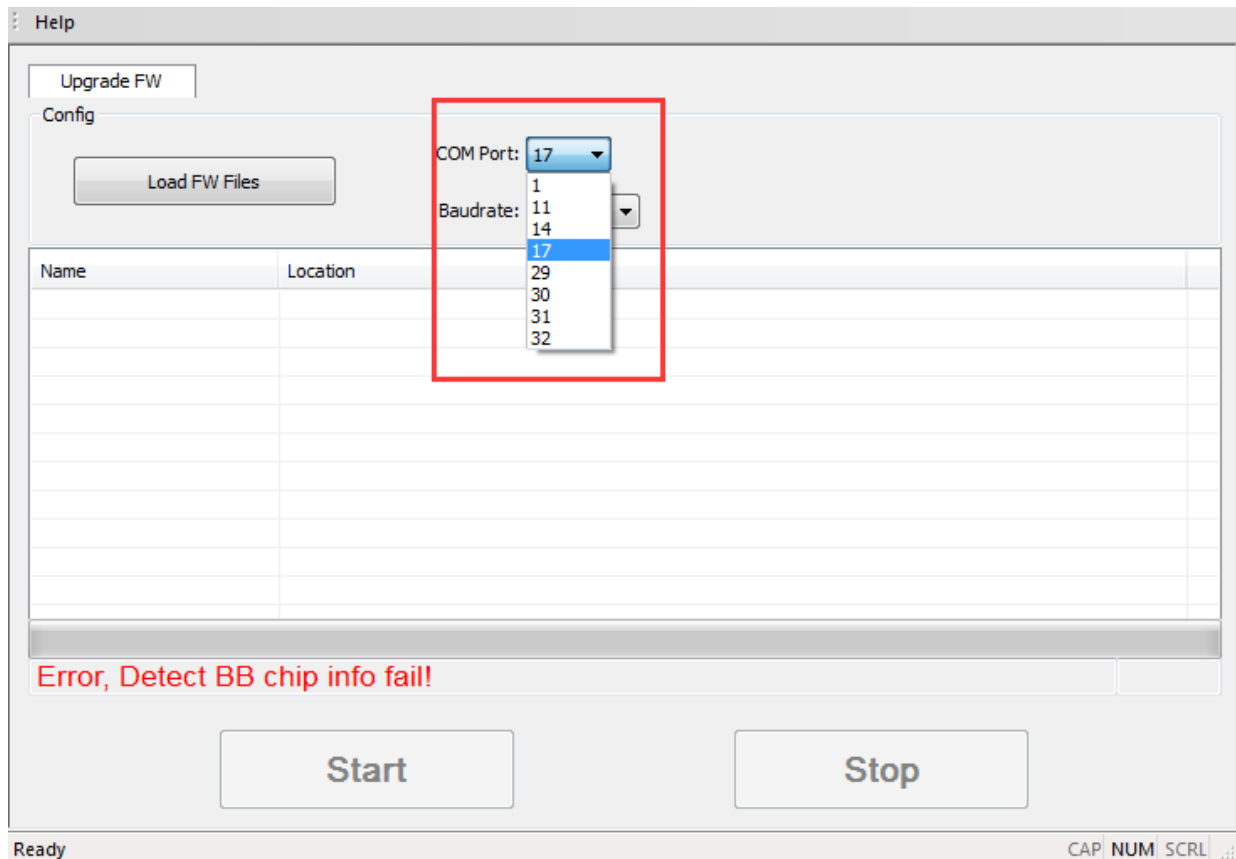
Click “**COM Port**” dropdown list to select the COM port on which the firmware is upgraded. As shown in the following figure.

Figure 3: Select the Correct Serial Port for Mxx/GCxx/BCxx Modules

1. For Mxx modules, it is the main UART to be used for firmware upgrade. After the port is selected, please manually restart the module.
2. For GCxx modules, it is the USB port to be used for firmware upgrade, and then the module will be automatically restarted.
3. For BCxx modules, it is the main UART to be used for firmware upgrade. After the port is selected, please click the “**Start**” button to wait for the prompt “**Module Reset By Hand**”, and then manually restart the module.

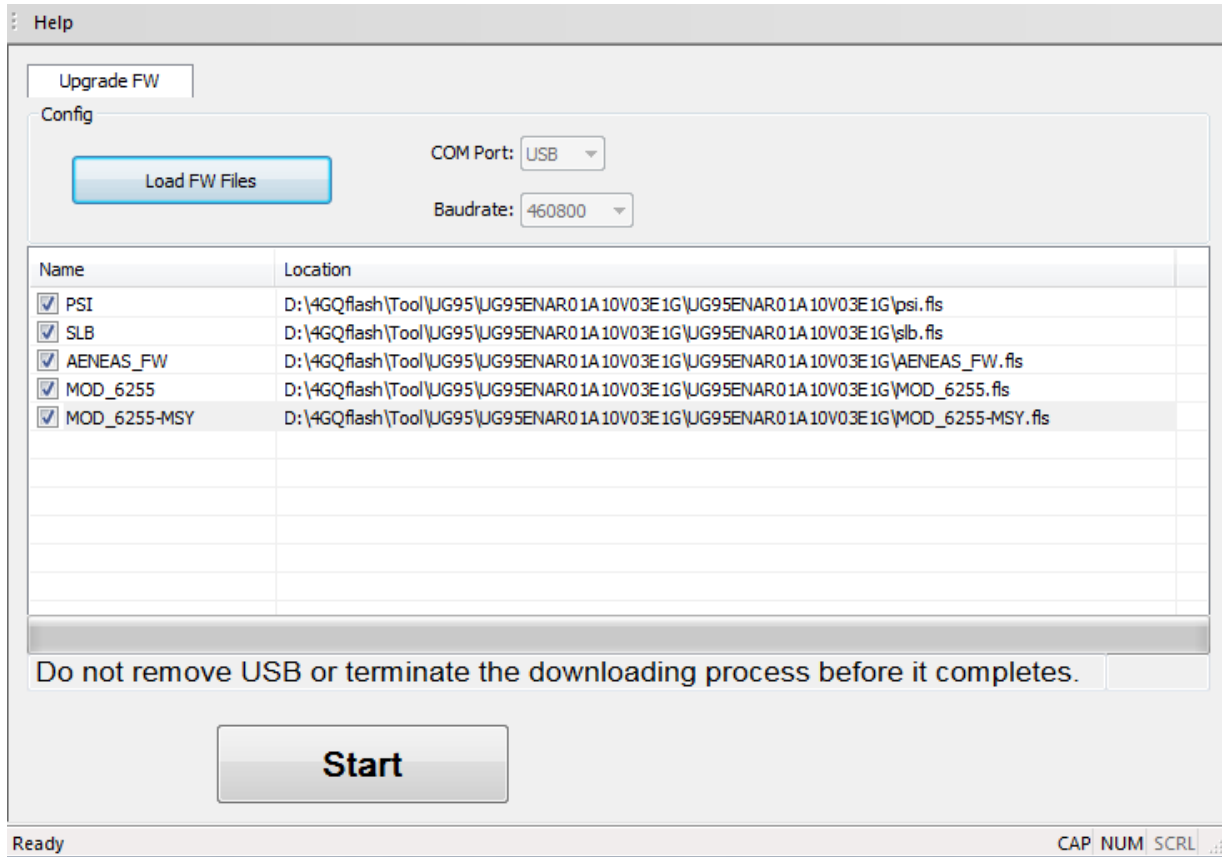
For UGxx modules, it is the USB port to be used for firmware upgrade, and it can be selected automatically. When firmware files are uploaded, “COM Port” dropdown list will display “USB” in gray. Then the module will be automatically restarted and ready to upgrade, and the USB port will be identified. The interface is shown in the following figure.

Figure 4: No Need to Select COM Port for UGxx Modules

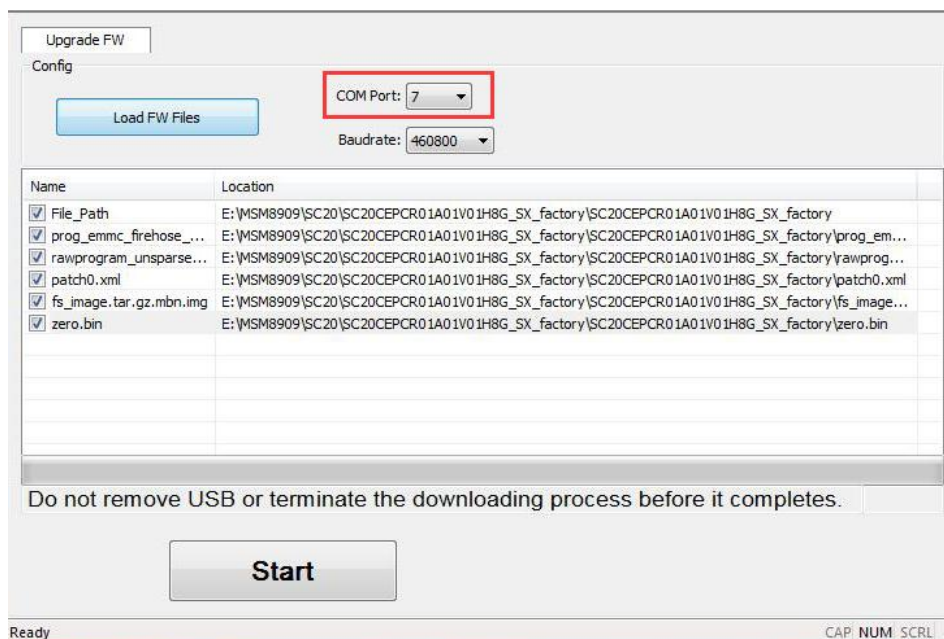
For SCxx/SGxx modules, HS-USB Diagnostics 9091 port can be used for firmware upgrade. Click “**COM Port**” dropdown list and select the HS-USB Diagnostics 9091 port for upgrade, as shown in the following figure.

Figure 6: Select the HS-USB Diagnostics 9091 Port for SCxx/SGxx Modules

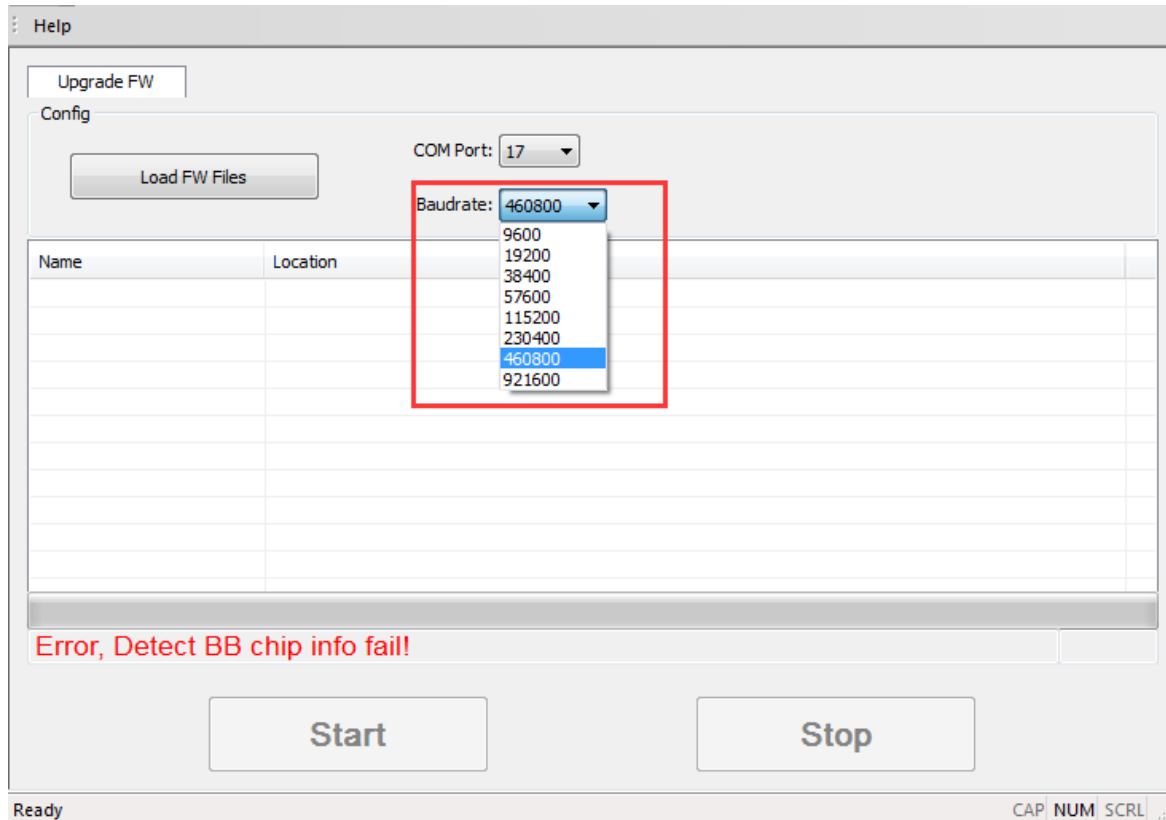
Click the “**Baudrate**” dropdown list and select an appropriate baud rate. It is recommended to select 921600 for GCxx modules and 460800 for other Quectel modules, as shown in the following figure.

Figure 7: Select the Baud Rate

1. Baud rates have many different values, and it is the hardware environment that determines whether a specified baud rate can be supported. If not supported, an error message will be returned.
2. Please do select 921600 baud rate when upgrading GCxx modules. Other baud rates may lead to upgrading operation failure.
3. Please do select 9600 baud rate when upgrading BCxx modules. Other baud rates may lead to upgrading operation failure.
4. Baud rate setting is unnecessary for USB virtual port.

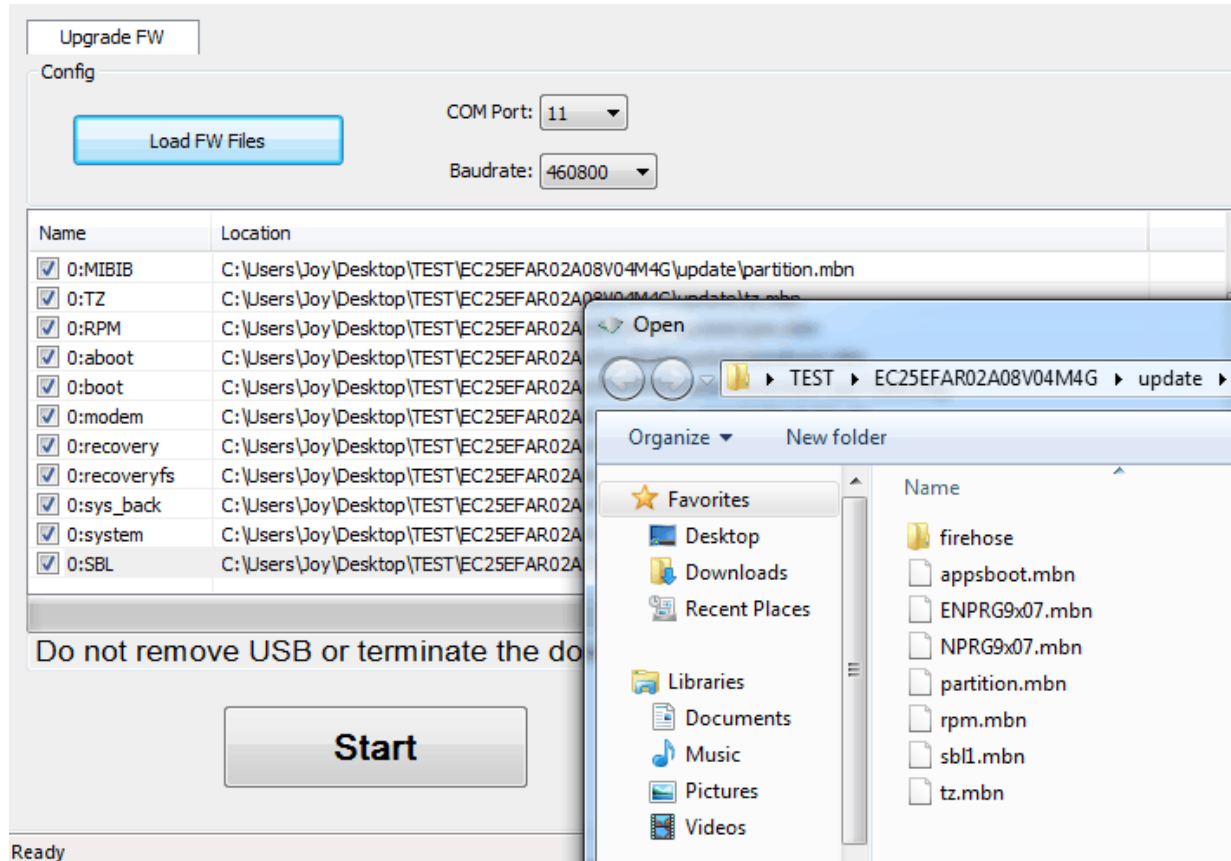
Step 1: Click the button “Load FW Files”.

Step 2: Select the *.txt*, *.cfg*, *.mbn*, *.lod*, *.fls* or *.fwpkg* file which needs to be downloaded to the module.

Figure 8: Select the File to be Downloaded

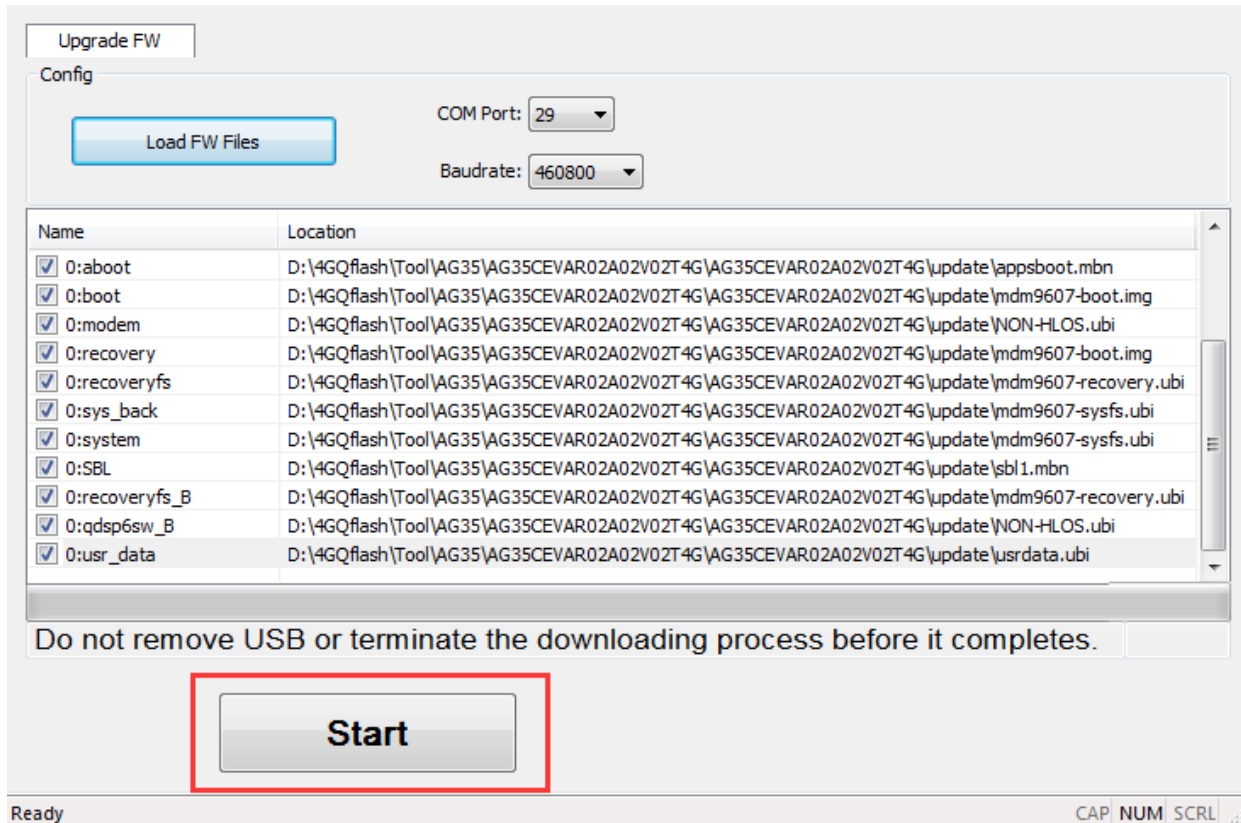
Step 1: Click “**Start**” button to upgrade the firmware. There is no “**Stop**” button while upgrading firmware for GCxx/UCxx/UGxx/ECxx/EG9x/Ex06/SCxx/SGxx/BCxx/EM05/AG35/BG96 modules, as shown in the following figure.

Figure 11: Click the Start Button

1. Please note that it is NOT permitted to stop the upgrading process, and please do NOT remove USB or terminate the downloading process before upgrading is completed.
2. For ECxx modules, if the firmware contains a Firehose folder, then it will be downloaded in Firehose mode by default.

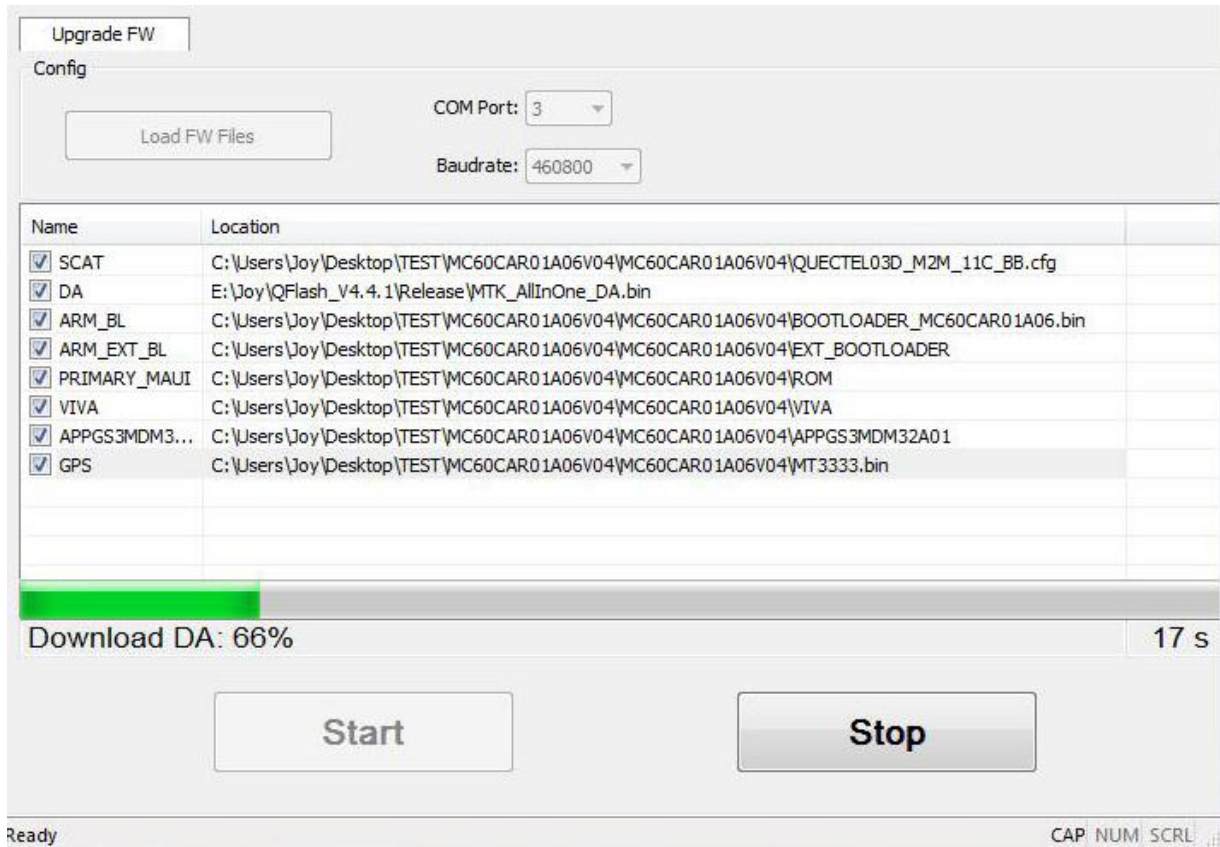
Step 2: For Mxx/BCxx modules, switch the D/L to “ON” on EVB after clicking “Start” button in 30 seconds, and then manually restart the module. It will start to upgrade the firmware as shown in the following figure.

Figure 12: Start to Upgrade after Restarting the Mxx Modules

On Mxx modules, please make sure the EVB is powered by 5V power supply when switching the D/L to “ON”, and then manually restart the module.

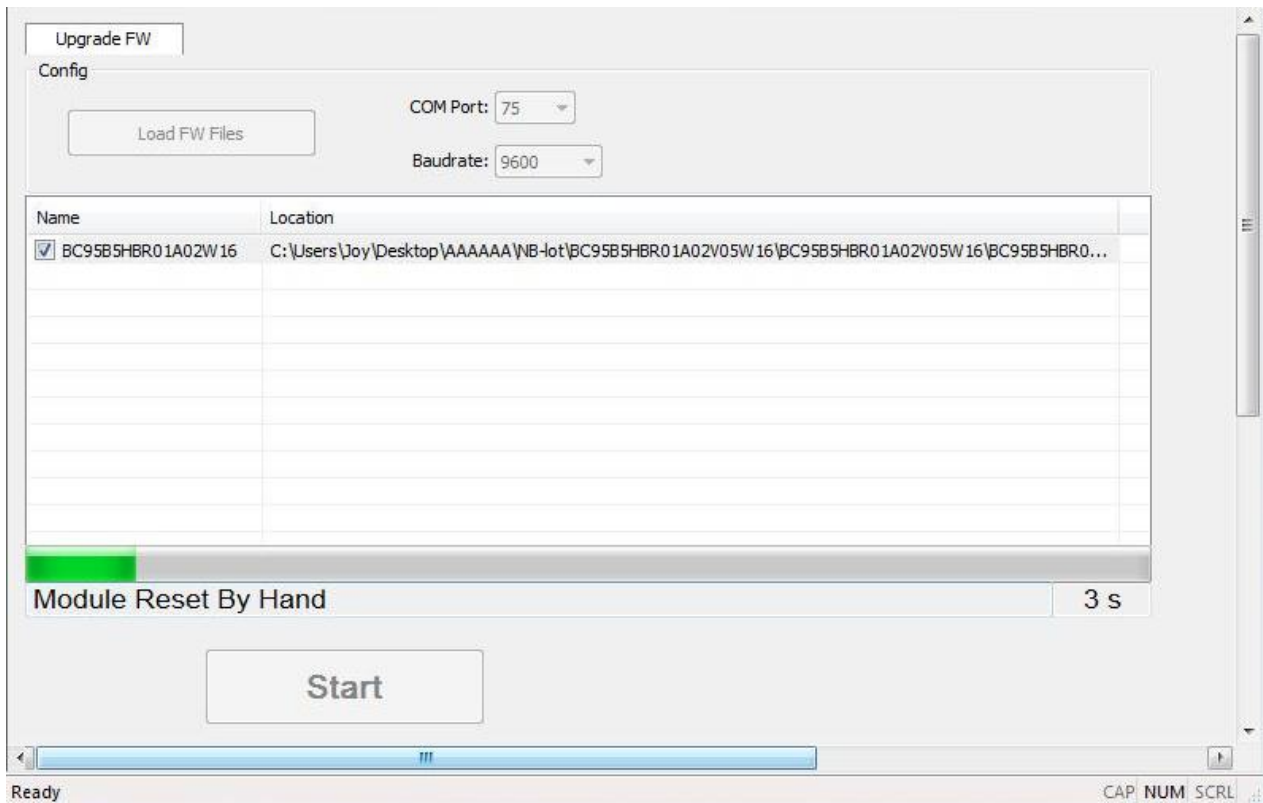
Figure 13: Start to Upgrade after Restarting the BCxx Modules

On BCxx modules, please make sure the EVB is powered by 5V power supply when switching the D/L to “ON”, and click the “**Start**” button to wait for the prompt “**Module Reset By Hand**”, then manually restart the module.

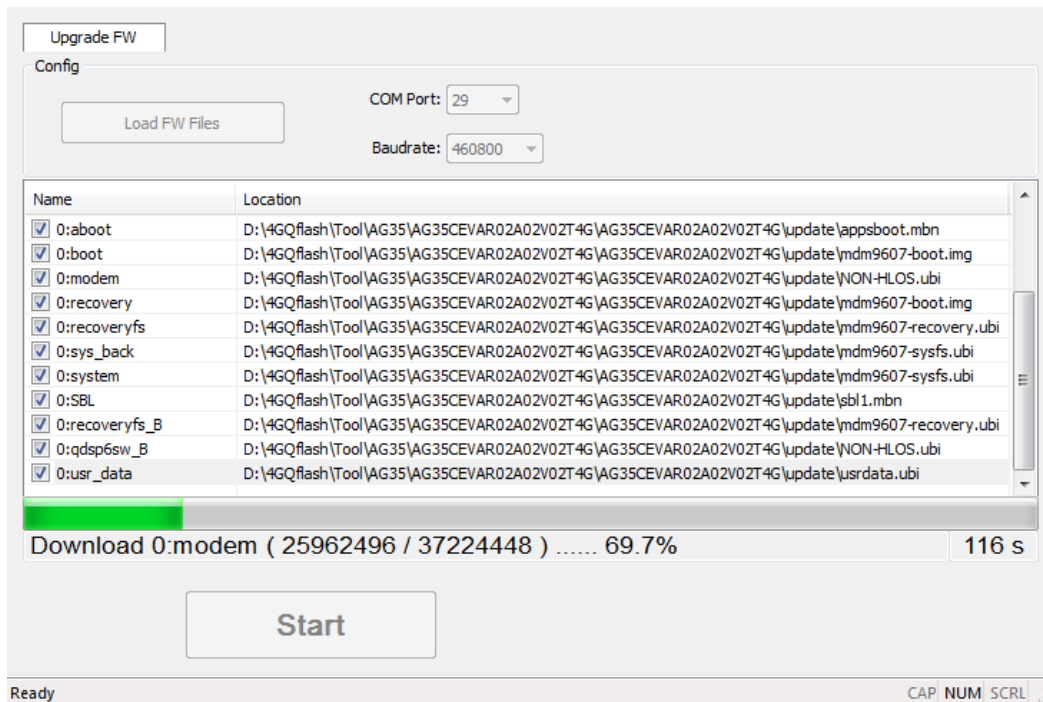
If users are upgrading the firmware for GCxx/UCxx/UGxx/ECxx/EG9x/Ex06/SCxx/SGxx/EM05/AG35/BG96 modules, the module will be restarted automatically, so there is no need to restart the module. Please refer to the following figure.

Figure 14: Start to Upgrade Firmware

If there is no EVB for module firmware upgrading, please drive the PWRKEY pin to low level after clicking the “Start” button in 30 seconds.

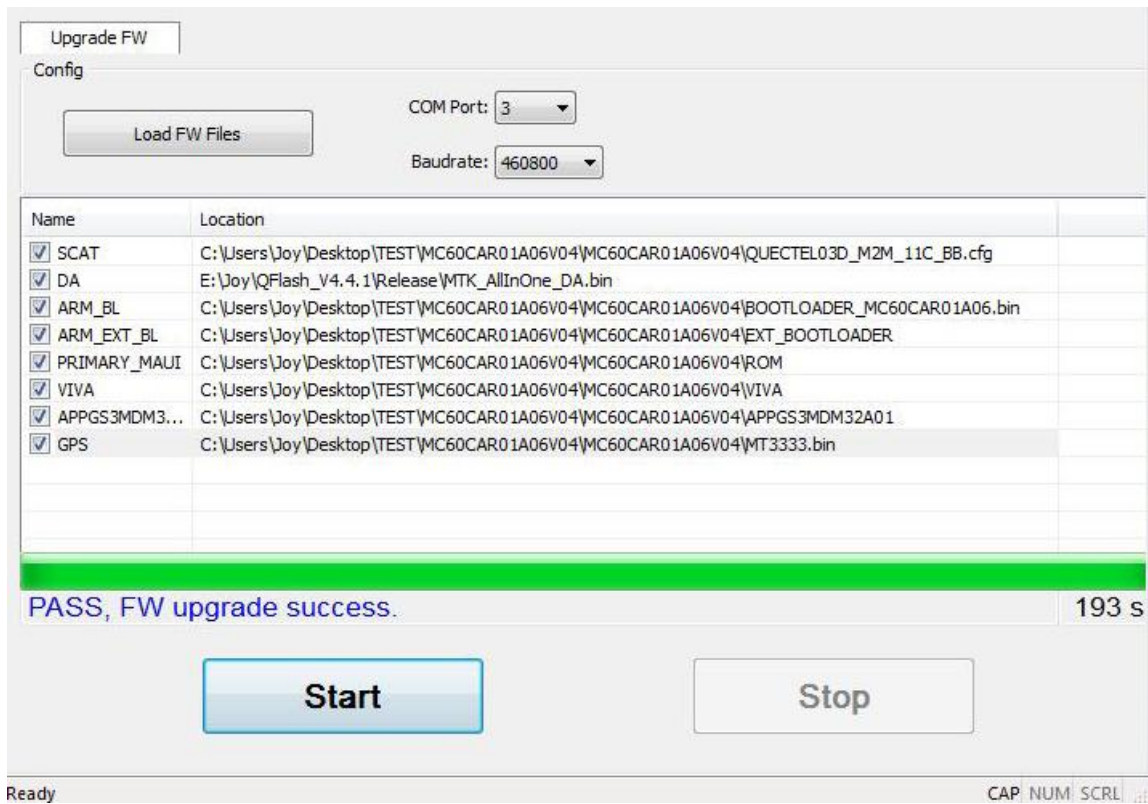
Step 3: “FW upgrade success” will be shown on the interface after the firmware has been successfully upgraded, as shown in the following figure.

Figure 15: Successful Upgrade

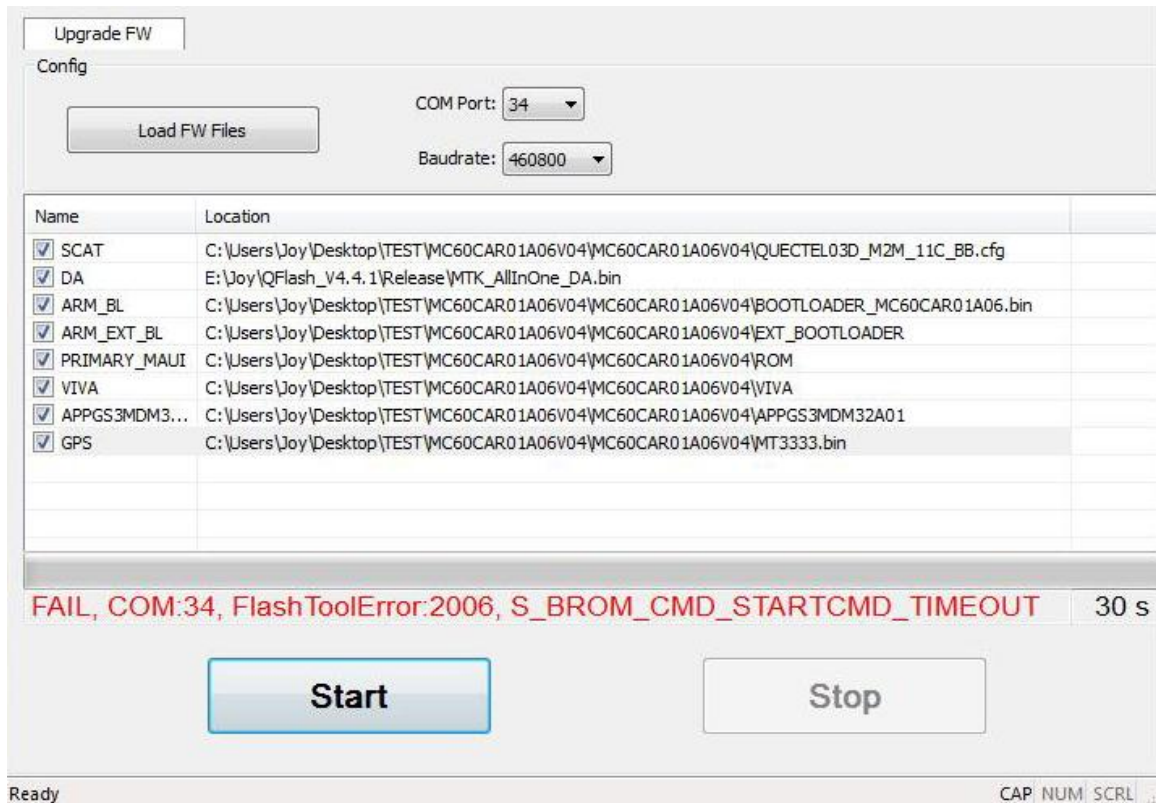
Figure 16: Connected to a Wrong Serial Port (Mxx Modules)

After selecting a correct serial port, if the Mxx modules are not restarted, then the error message will be the same as that of selecting a wrong serial port.

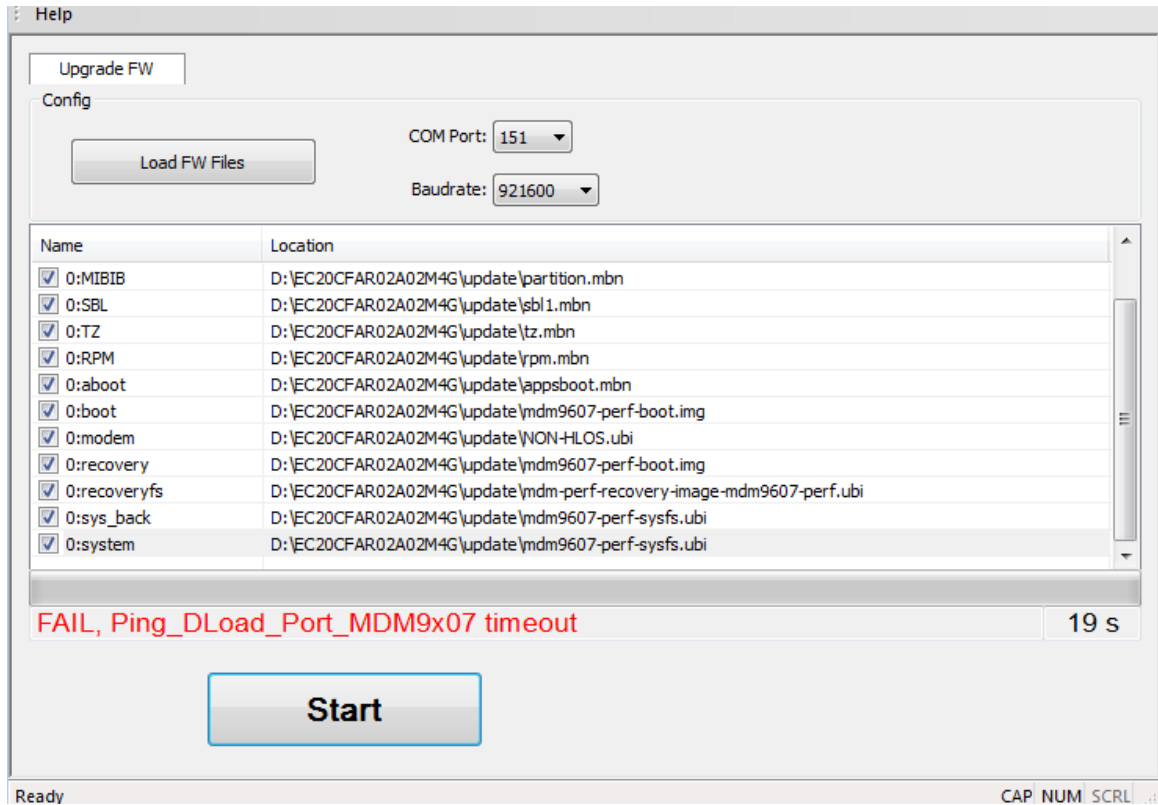
Figure 19: Connected to a Wrong Serial Port (ECxx/EG9x/Ex06/EM05/BG96 Modules)

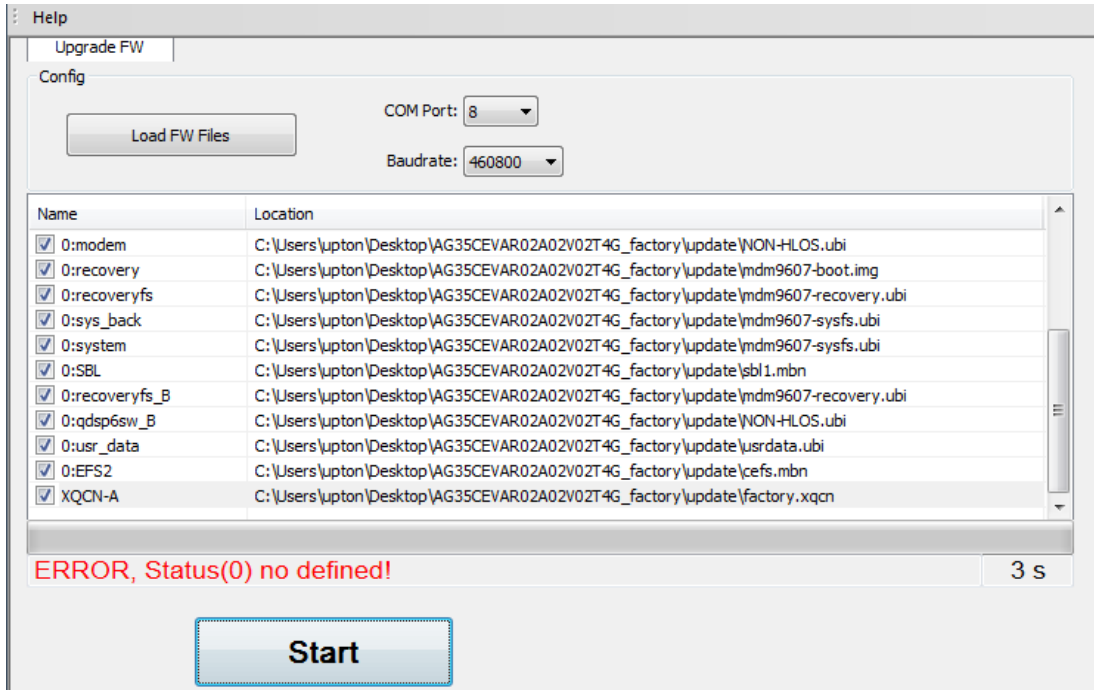
Figure 21: Connected to a Wrong Serial Port (AG35 Module)

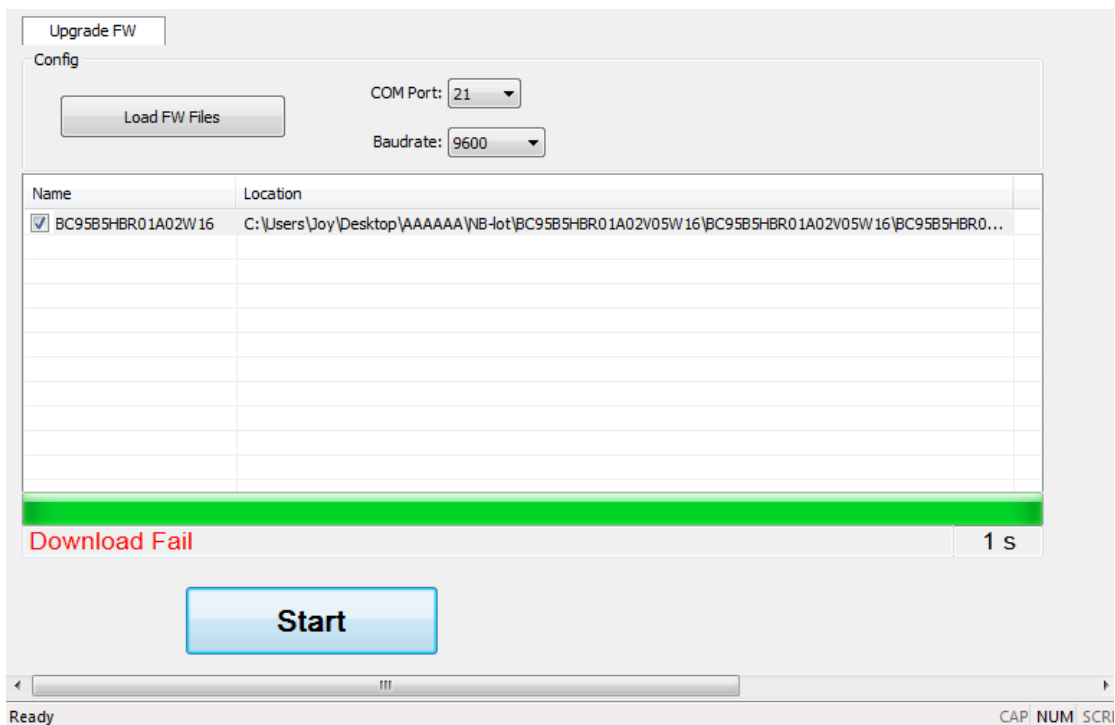
Figure 22: Connected to a Wrong Serial Port (BCxx Modules)

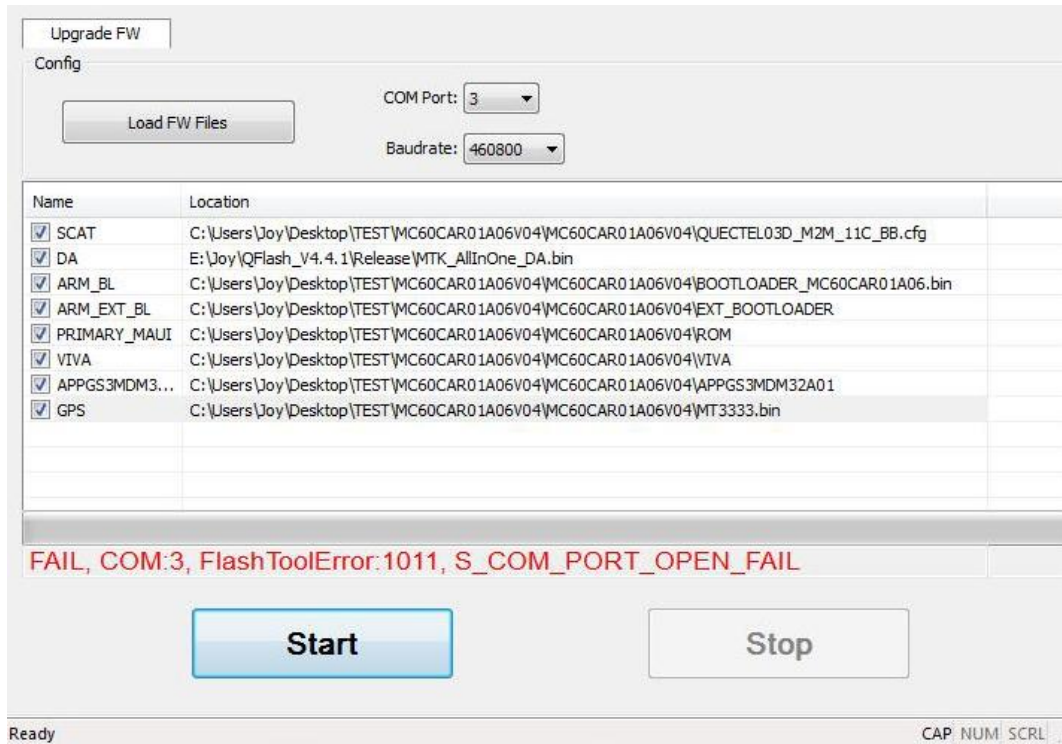
Figure 23: Connected to an Occupied Serial Port (Mxx Modules)

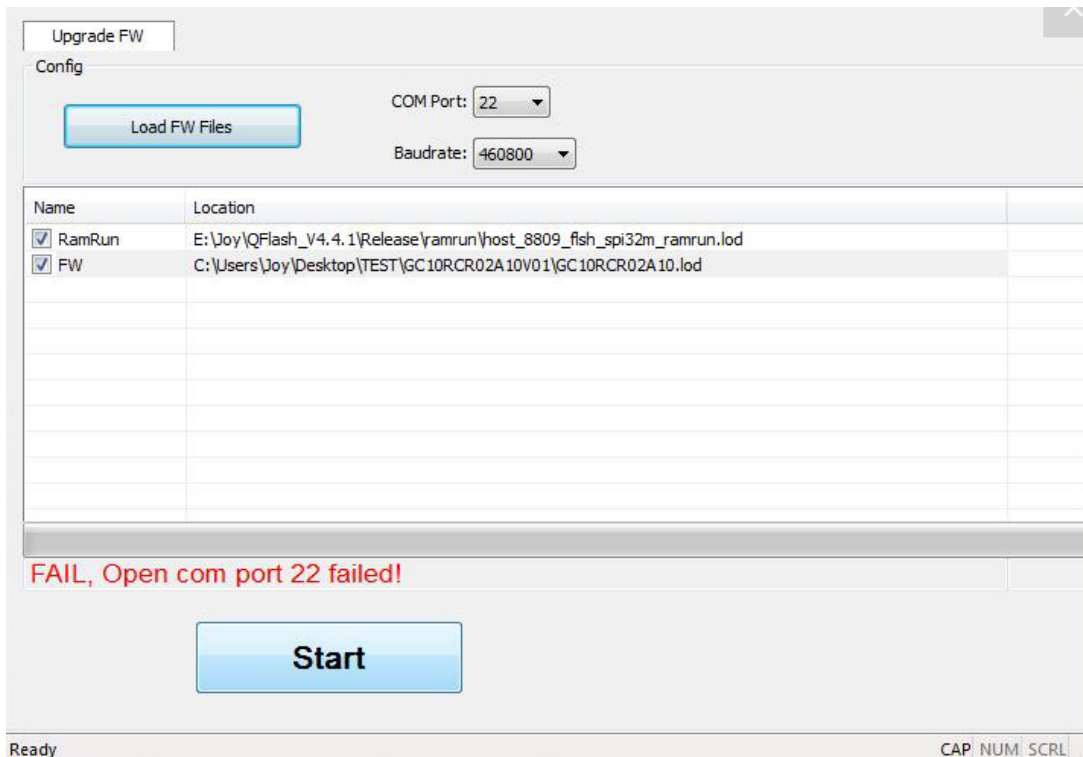
Figure 24: Connected to an Occupied Serial Port (GCxx Modules)

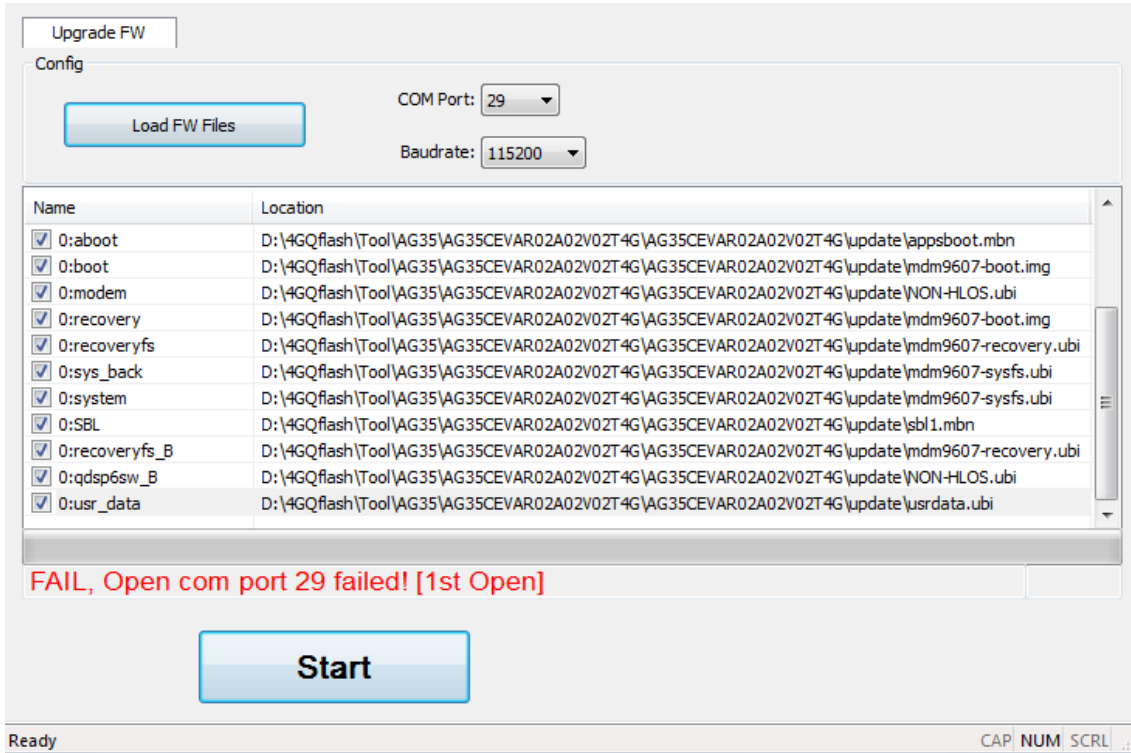
Figure 25: Connected to an Occupied Serial Port (UCxx/ECxx/EG9x/Ex06/SCxx/SGxx/EM05/AG35/BG96 Modules)

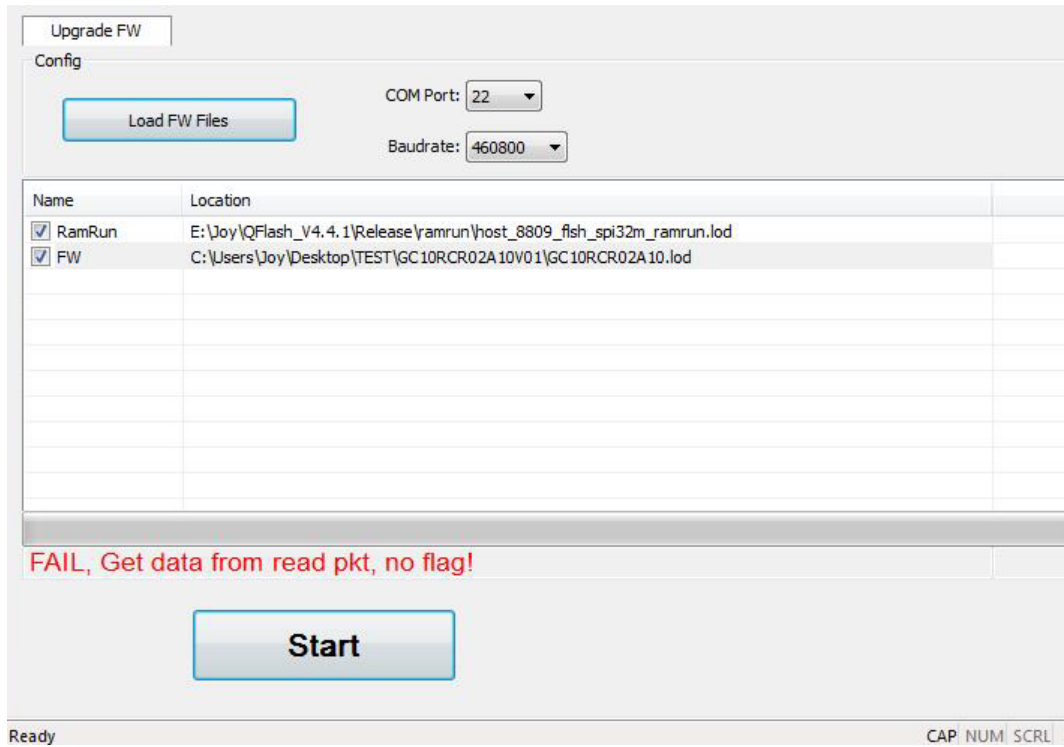
Figure 28: An Unsupported Baud Rate is Selected (GCxx Modules)

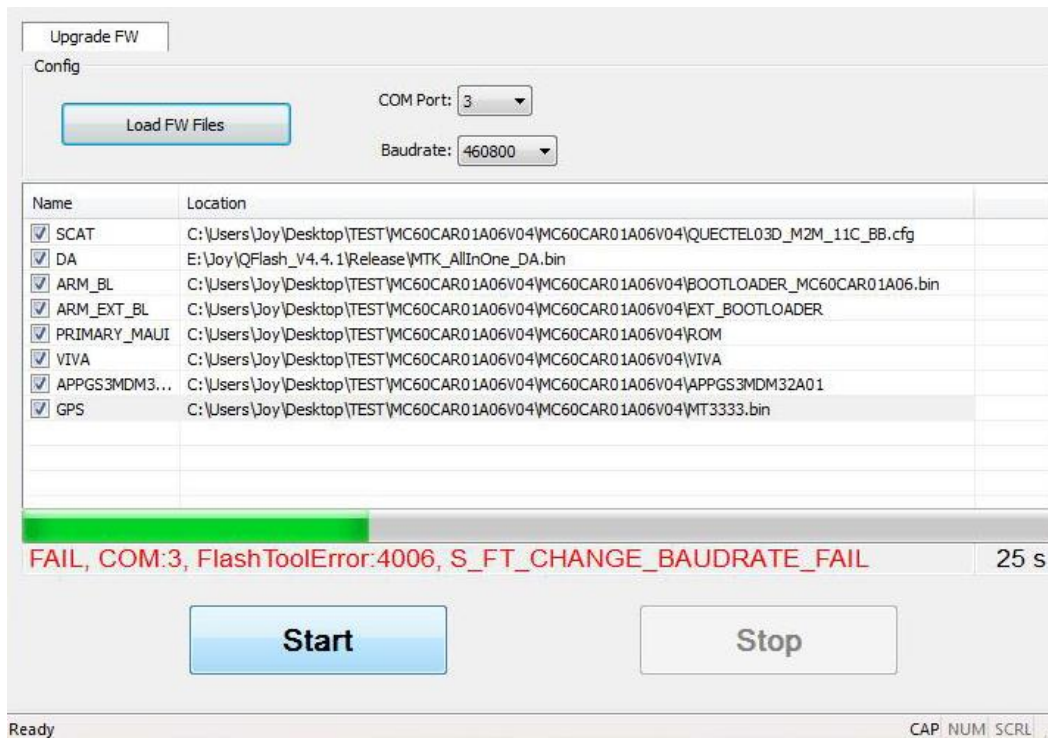
Figure 35: Power Supply is Abnormal (Mxx Modules)

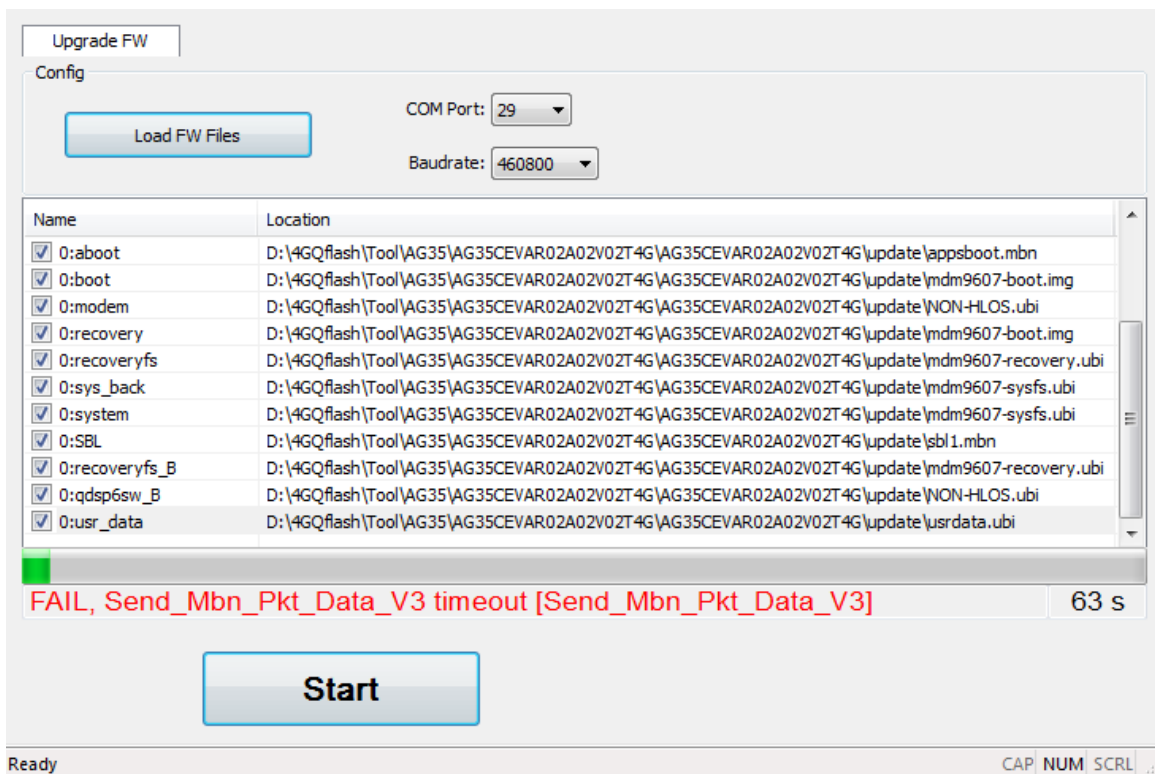
Figure 37: Power Supply is Abnormal (UCxx/ECxx/EG9x/Ex06/EM05/AG35/BG96 Modules)

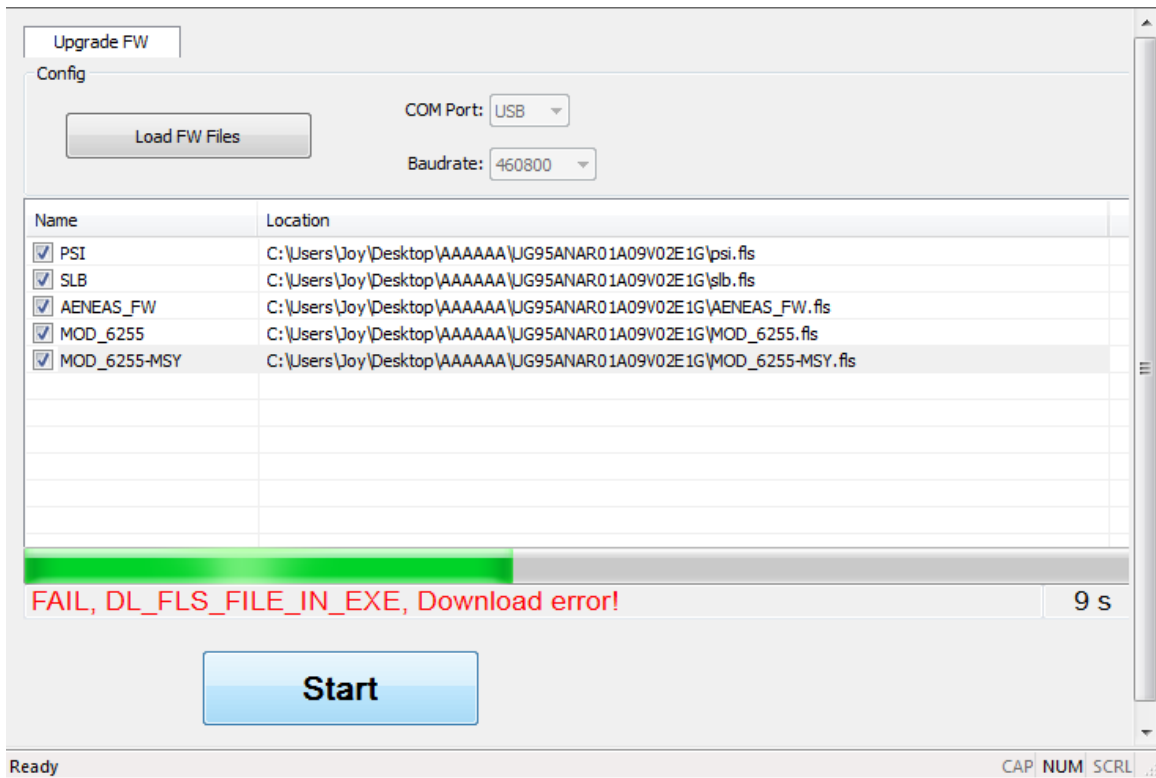
Figure 38: Power Supply is Abnormal (UGxx Modules)

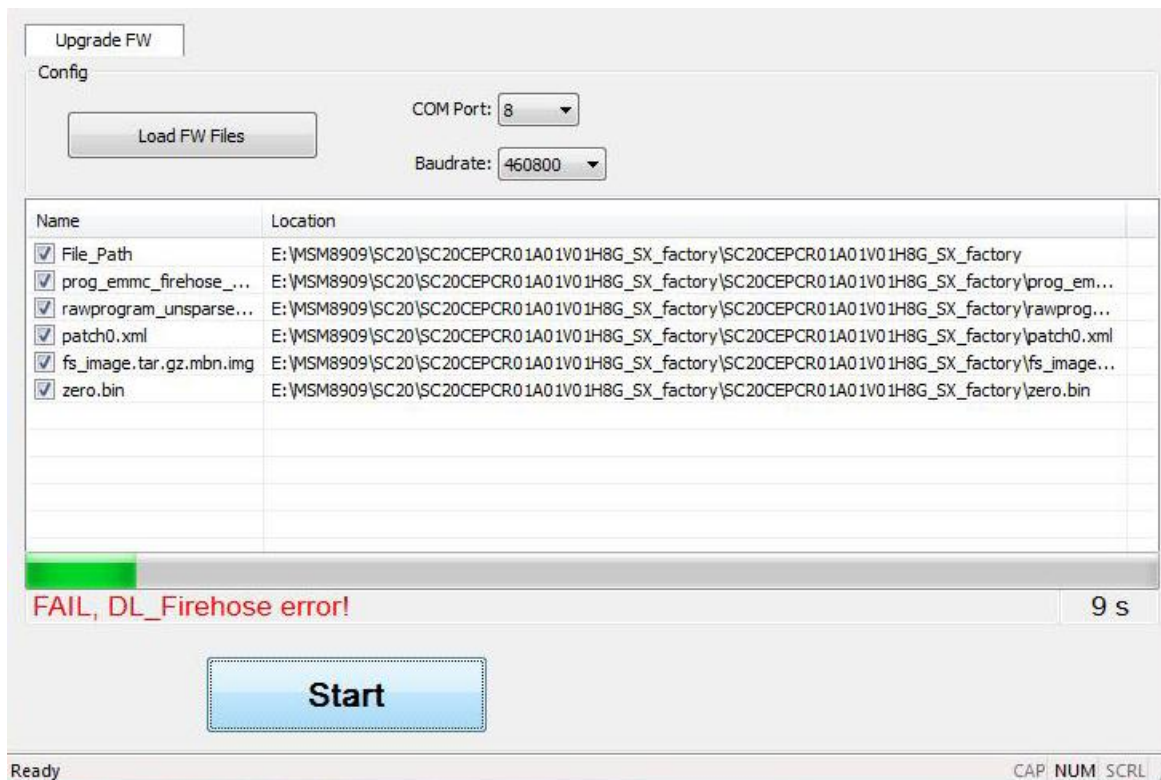
Figure 39: Power Supply is Abnormal (SCxx/SGxx Modules)
