QFlash User Guide

Rev. QFlash_User_Guide_V2.2

1 Introduction

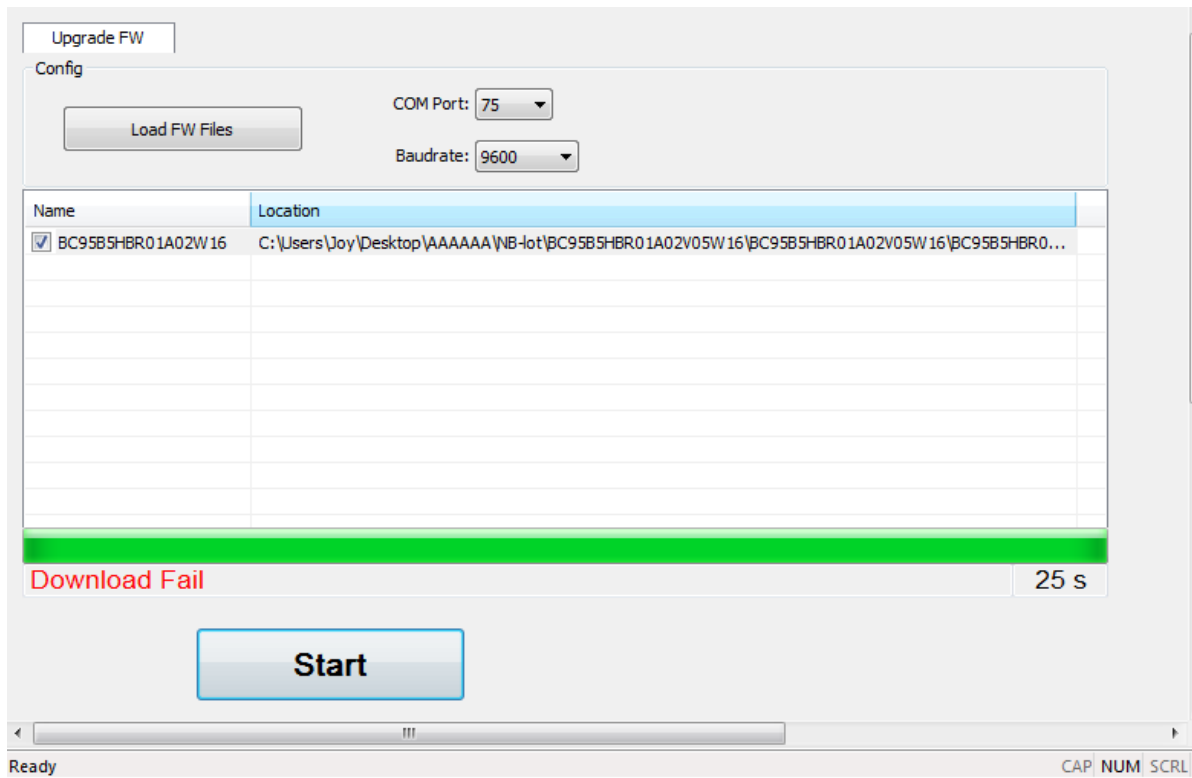
Figure 40: Power Supply is Abnormal (BCxx Modules)

Abnormalities may be caused by incorrect parameter of baud rate, damaged EVB or invalid files, etc. The following illustrates some common abnormalities.
